Outstanding Projects for 2003

Medicine Lodge Creek Total Maximum Daily Load (TMDL) Implementation Project

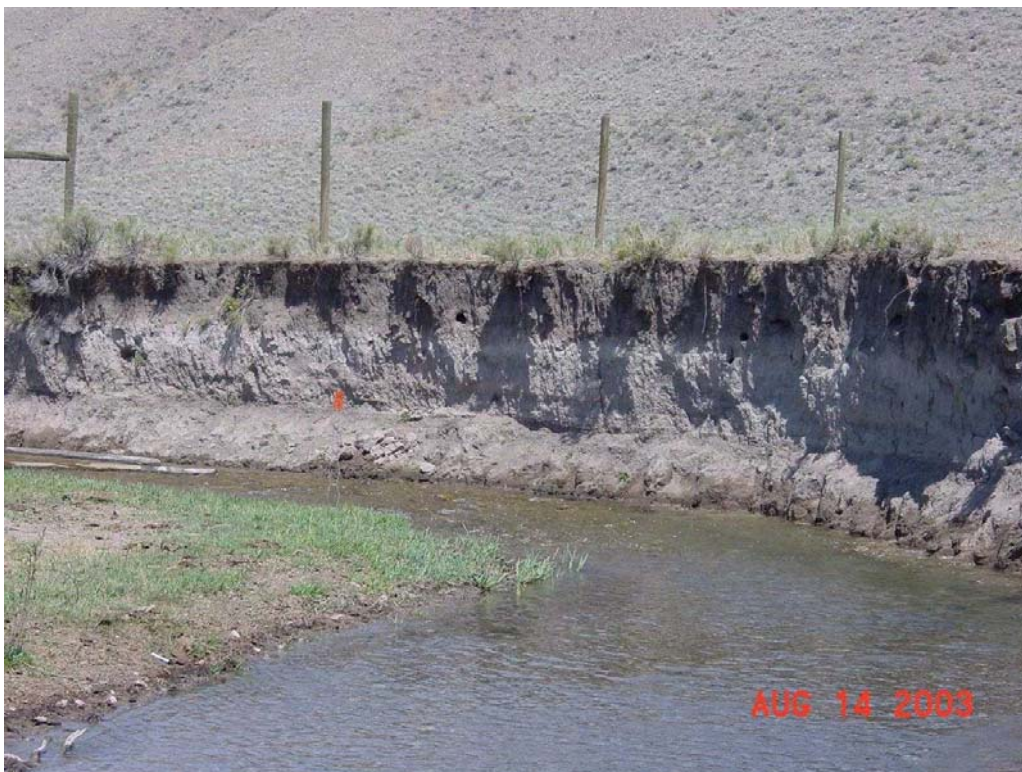
Figure 22: Problems that are routinely found along Medicine Lodge Creek include unstable, steep stream banks caused by improper grazing techniques. This problem has been exacerbated by unusual weather patterns over recent years.

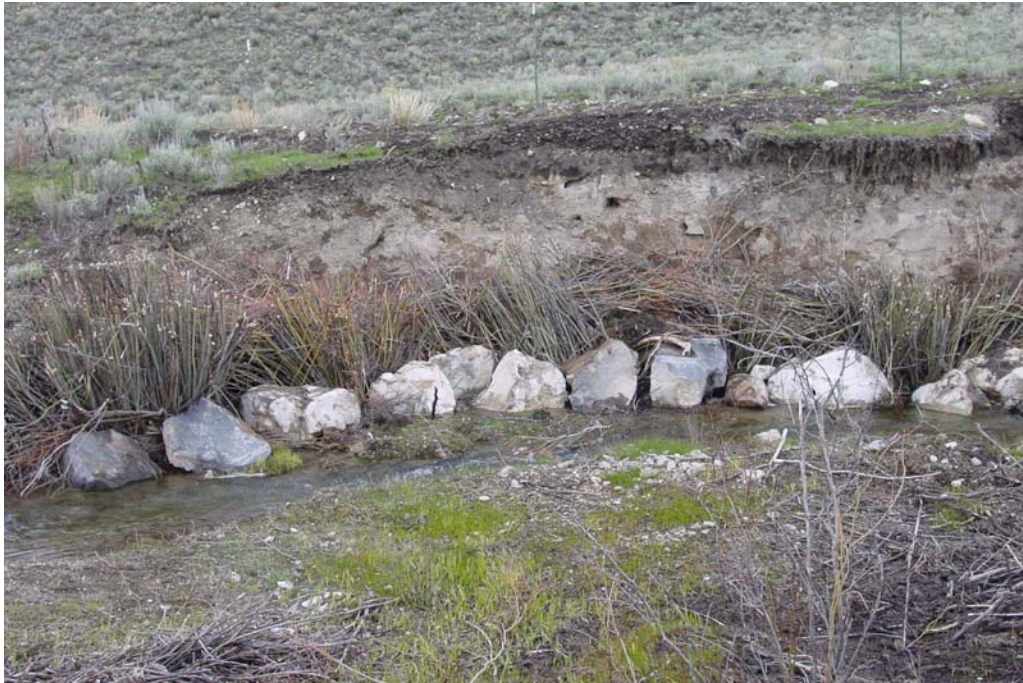
Figure 23: One solution to bank erosion is to carefully place rip-rap and woody vegetation at the toe of the bank. With time, this bank will become completely vegetated and stabilized.

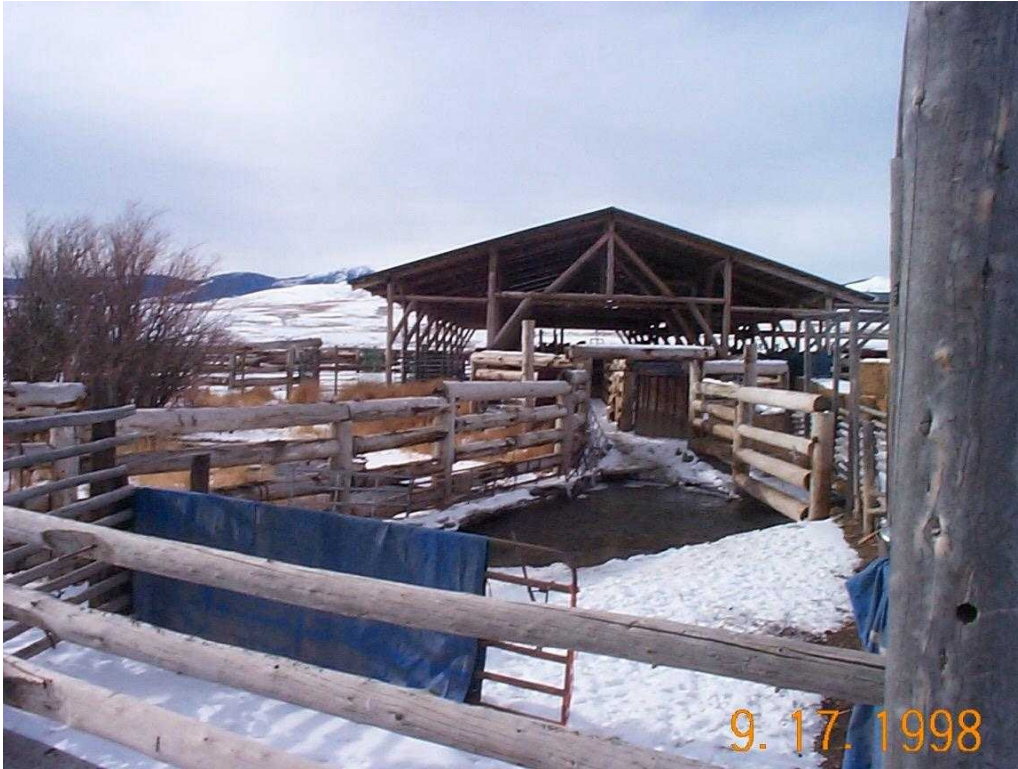
Another common problem along Medicine Lodge Creek is that confined animal feeding operations (CAFOs) have historically been placed in and adjacent to streams in order to provide water for livestock. The CAFO seen in Figure 24 used to be located in Irving Creek. This facility was recently relocated away from Irving Creek and now has water piped into it.

Figure 24: Confined Animal Feeding Operation relocated away from Irving Creek

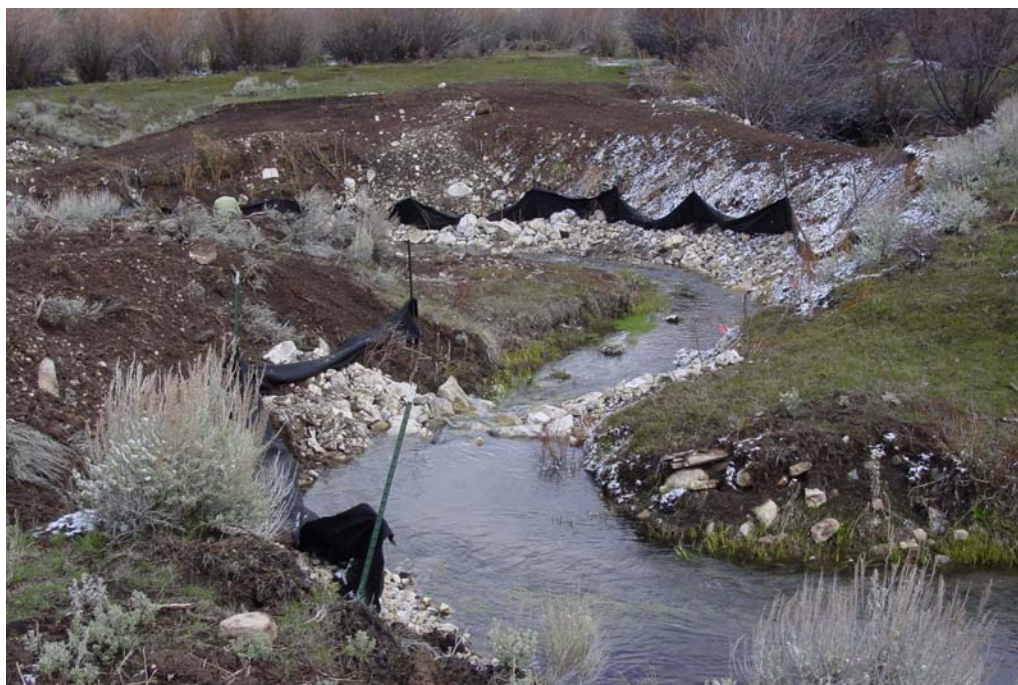
Figure 25: Vertical slopes from overgrazing were knocked down. Rip-rap and willows were added to stabilize the bank. This looks unsightly now but will appear quite natural after one or two growing seasons. The biodegradable silt fencing will break down.

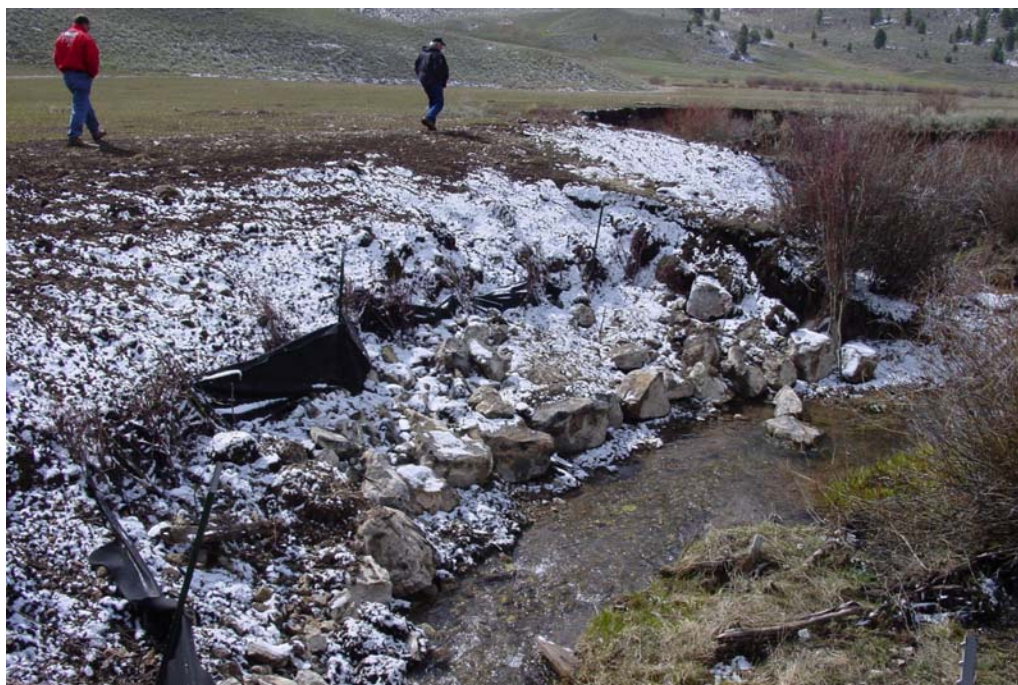
Figure 26: The stream bank in the foreground has been re-sloped, stabilized with rip-rap, and replanted. The vertical stream bank in the background has not yet been rehabilitated.

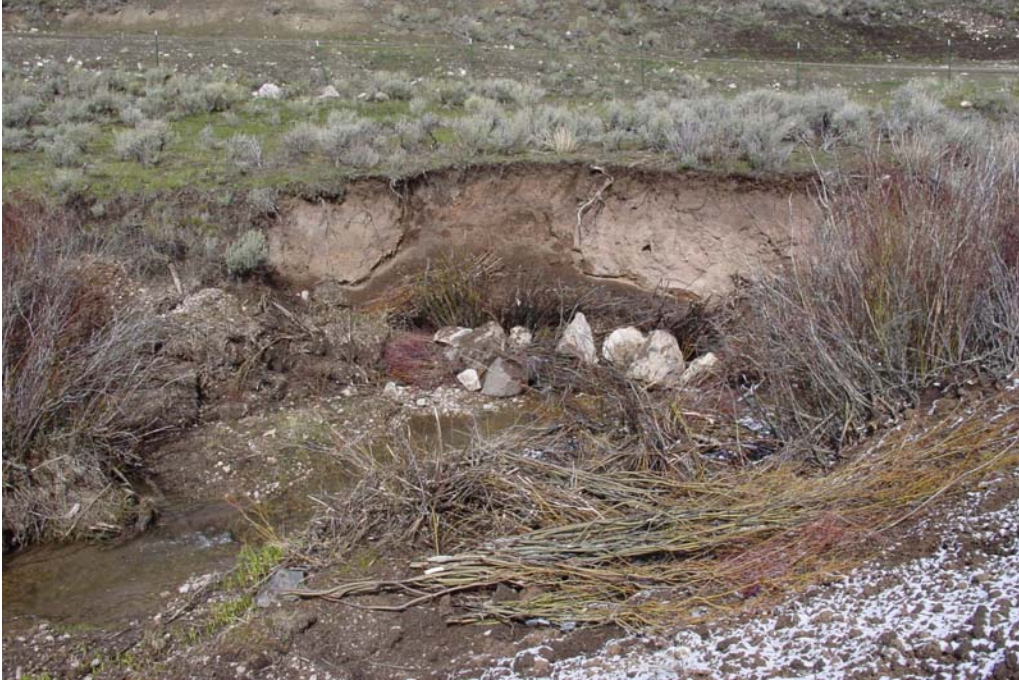
Figure 27: Willows were planted as horizontal bundles and as transplanted rooted clumps. All woody plants are locally derived. Many of the vertical banks were stabilized at their toe with large rocks and woody plants. The upper bank will slough back until stabilization is naturally achieved. Vegetation will then continue to establish itself naturally.

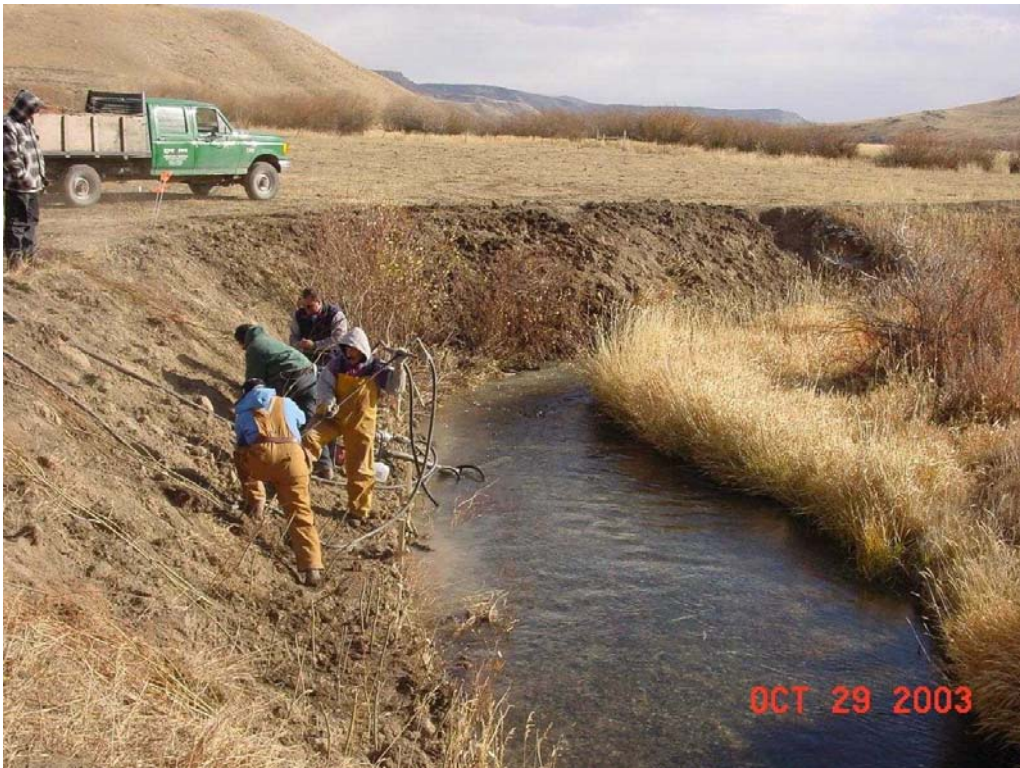
Figure 28: One effective method for planting willows involves the use of a water jet. This high-pressure water injection technique allows quick and easy planting of willow cuttings several feet deep along the bank and within the water table.

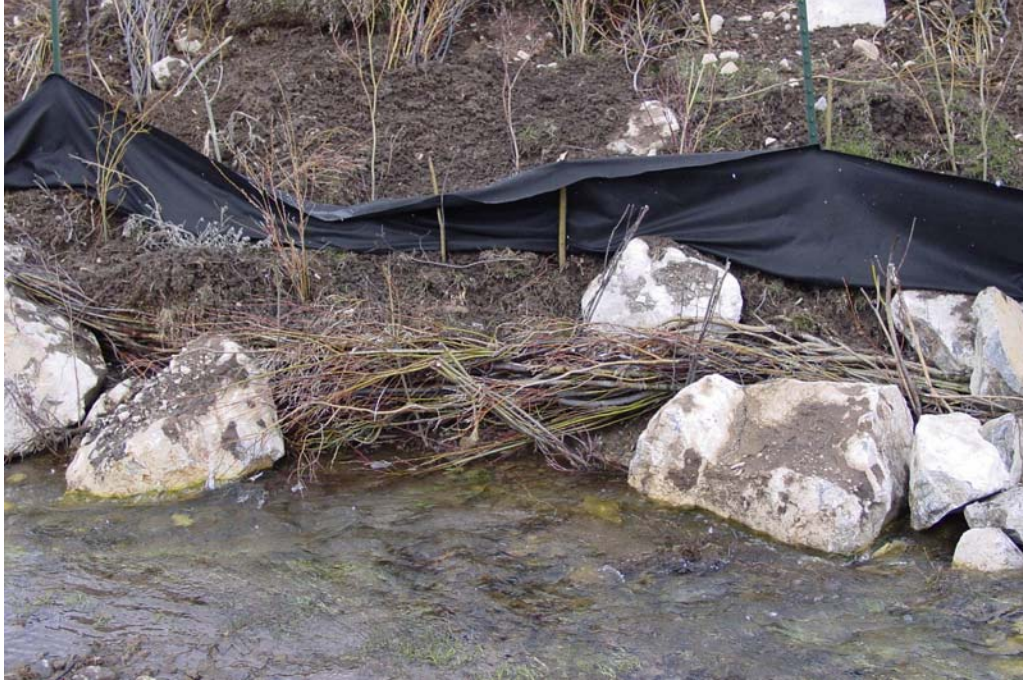
Figure 29: These willow cuttings were planted using water jet injection.

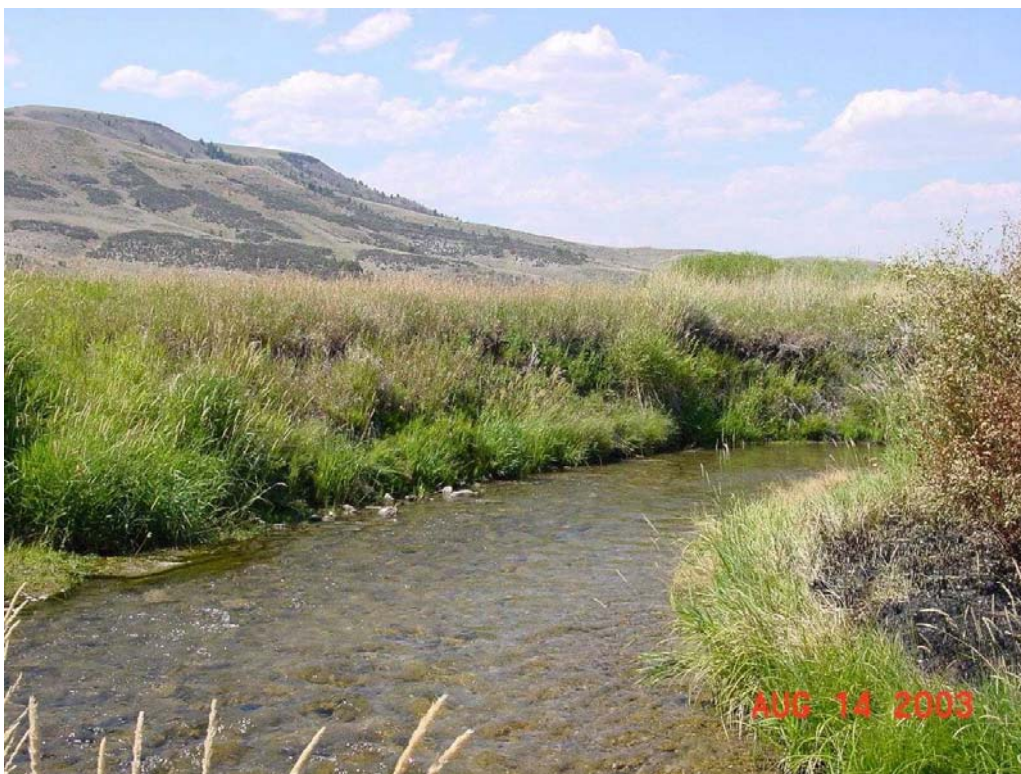
Figure 30: Within several years, all of the areas shown in the previous photographs will look as good and function as well as this section that was completed just two years ago.

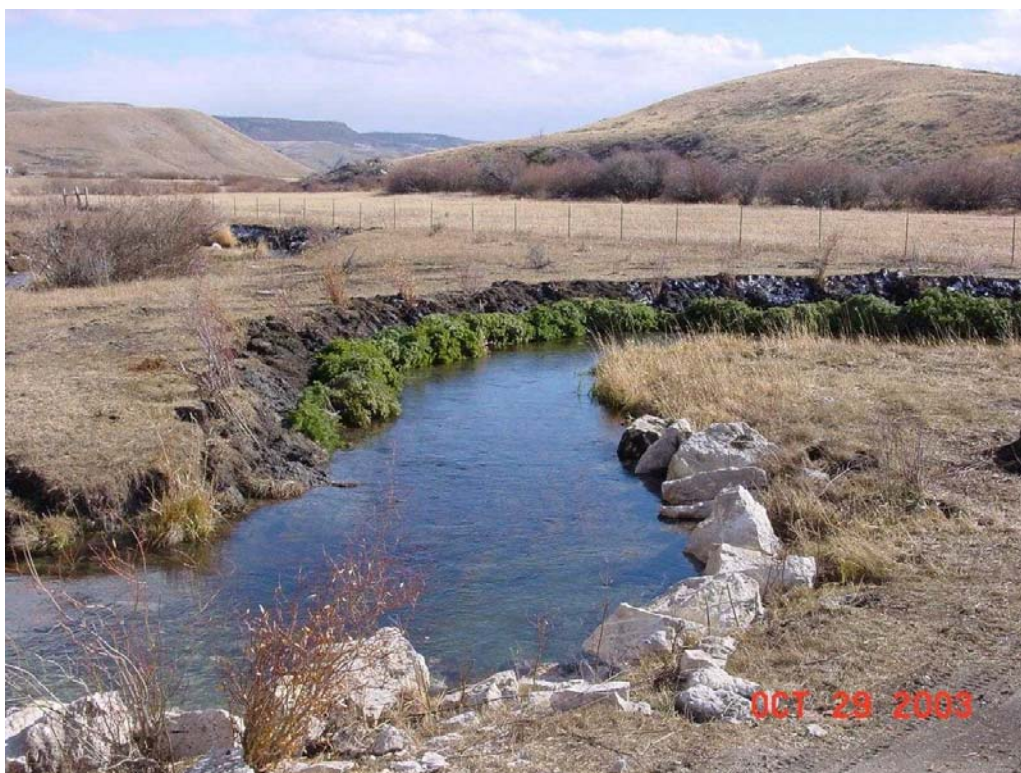
Figure 31: Stabilized stream bank
